2022 Water Quality Report

Lac La Biche Lake

East Basin

Prepared By:
Lac La Biche County
PO Box 1679
Lac La Biche Alberta, T0A 2C0, Canada

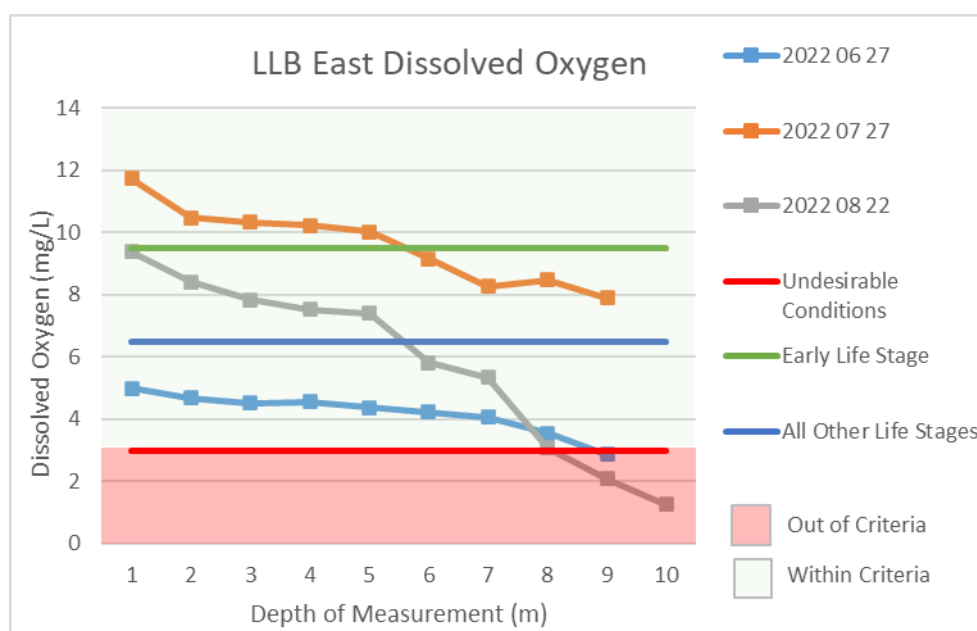
Figure 3: Dissolved oxygen in East Basin of Lac La Biche Lake - 2022

Dissolved oxygen levels in the East Basin of Lac La Biche Lake were recorded to a maximum depth of 10 m using multi-probe on June 27, July 27, and August 22, 2022. Unfortunately, a temperature profile was not taken in March 2022 due to complications with the multi-probe. A maximum dissolved oxygen concentration of 11.73 mg/L on July 27, 2022, at a depth of 1 m which declined to 7.91 mg/L at the lakebed (Figure 4). The average dissolved oxygen over the sampling period was 6.55 mg/L.

In 2022, the dissolved oxygen data from East Basin indicated that the average dissolved oxygen levels for all sampling events ranged from 4.21 mg/L to 9.63 mg/L and within proximity to the regulatory criteria for dissolved oxygen in cold water lakes (9.5 mg/L for early life stages and 6.5 mg/L for all other life stages).

Dissolved oxygen data collected in 2022 shows that the average dissolved oxygen levels ranged from 4.21 mg/L to 9.63 mg/L. These concentrations were in proximity to the regulatory criteria for dissolved oxygen in cold water lakes for early life stages (9.5 mg/L) and for all other life stages (6.5 mg/L).

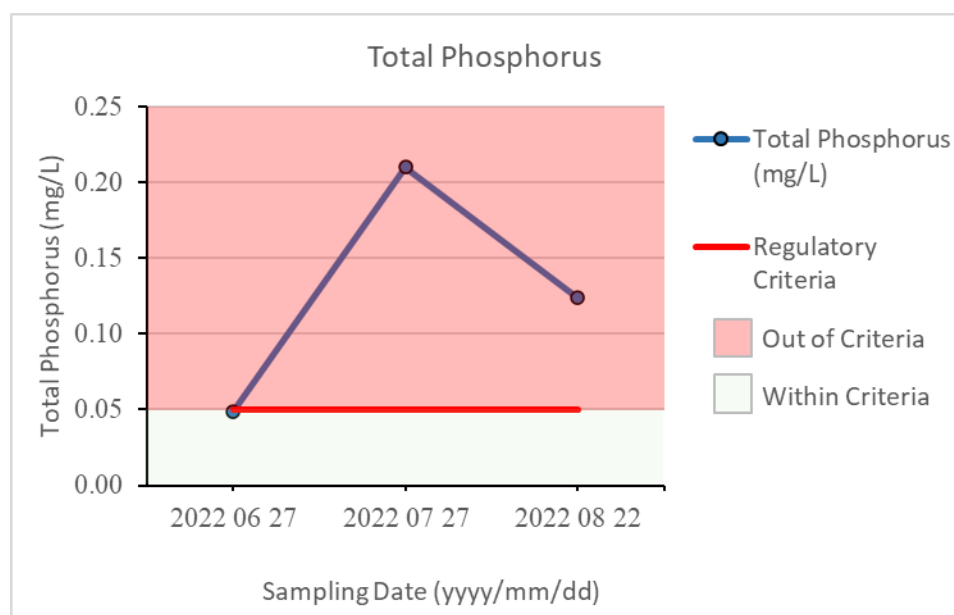
Figure 8: Total phosphorus from composite samples in East Basin of LLB Lake – 2022

Composite lake water samples for total phosphorous analysis were collected on June 27, July 27, and August 22, 2022 from the East Basin in Lac La Biche Lake. The analytical results are presented in Figure 8.

A minimum total phosphorous concentration of 0.049 mg/L was found in a sample collected on June 27, 2022 which increased to 0.210 mg/L on July 27, 2022. Excluding the month of June, the total phosphorous concentrations of all composite samples collected during 2022 exceeded the applicable regulatory guidelines (0.050 mg/L) with an average of 0.128 mg/L total phosphorus. This average total phosphorus concentration classifies the East Basin of Lac La Biche Lake as Hypereutrophic (excessive productivity, nutrients, and algae growth) based on total phosphorus from composite samples.

Total phosphorus concentrations in the composite samples collected during the summer of 2022 had an average of 0.128 mg/L of total phosphorus, while the Kemmerer samples collected had an average of 0.071 mg/L. Both the composite and Kemmerer samples of total phosphorus exceeded the applicable regulatory guidelines of 0.05 mg/L and were slightly lower than historical results. The average total phosphorus concentrations from composite and Kemmerer sampling classify the East Basin of Lac La Biche Lake as Eutrophic (high productivity, nutrients, and algae growth).

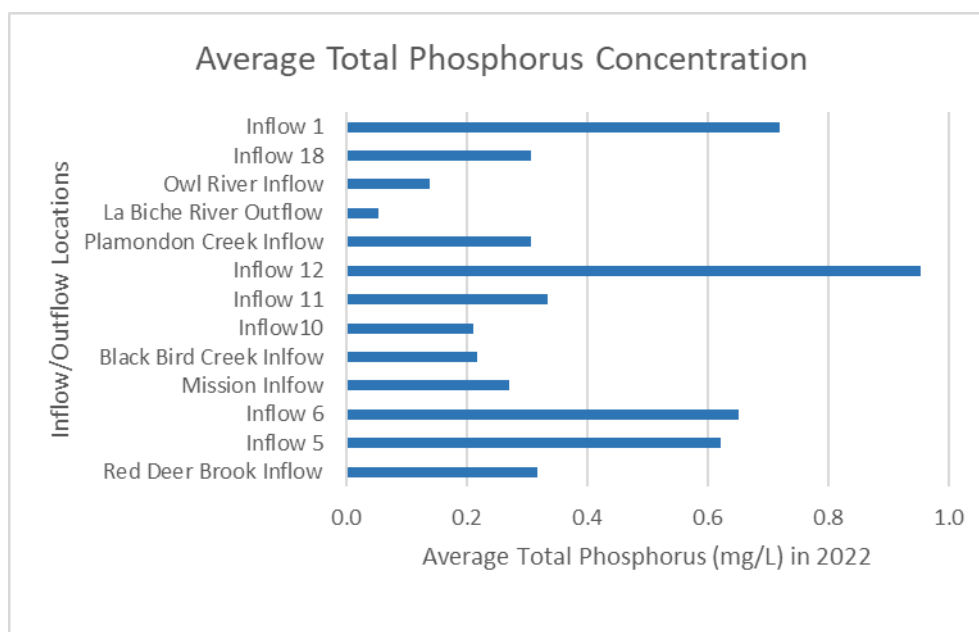
Figure 10: Inflow and outflow total phosphorous concentration for Lac La Biche Lake – 2022

It is important to note that the samples obtained from the inflows and outflows do not account for the flow rate of the water; therefore, this is not a true representation of concentrations found in the water.

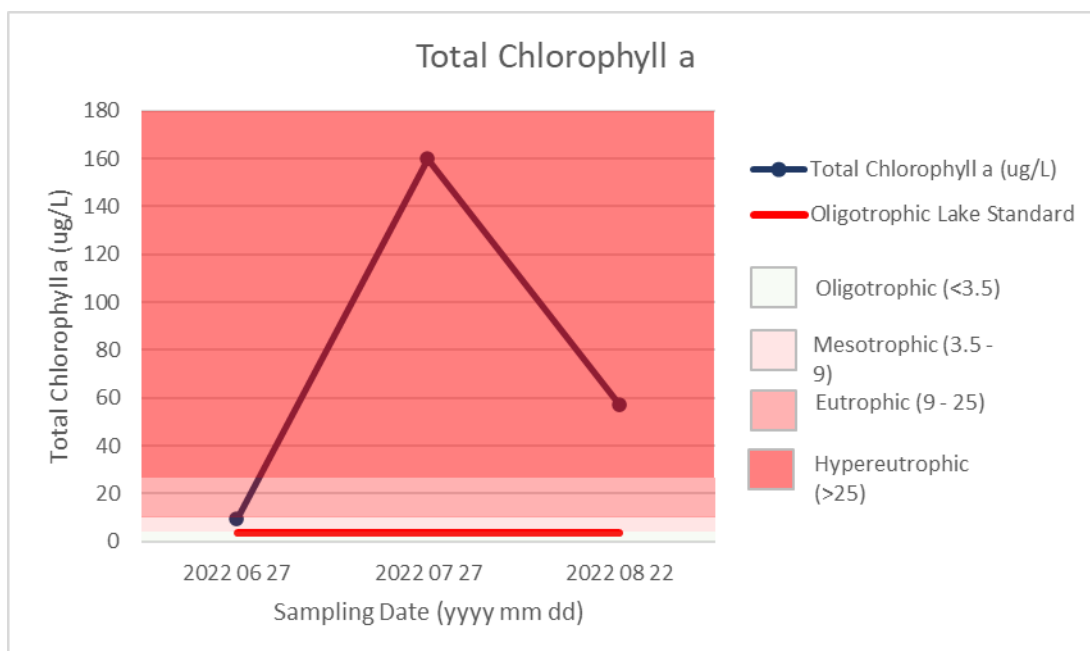
Figure 11: Total Chlorophyll-a from Composite samples in East Basin of LLB Lake - 2022

Composite lake water samples for filtering and analyses of chlorophyll-a were collected on June 27, July 27, and August 22, 2022. The analytical results of these samples are presented in Figure 11 below. A minimum concentration of 9.4 ug/L was observed on June 27, 2022. Chlorophyll-a concentrations peaked on July 27, 2022, at 160 ug/L, and decreased to 56.7 ug/L on August 22, 2022. Total chlorophyll-a concentrations in the samples collected during the summer of 2022 had an average of 75.37 ug/L of total chlorophyll-a, which classifies the East Basin of Lac La Biche Lake as Hypereutrophic

(excessive productivity, nutrients, and algae growth).

Total chlorophyll-a concentrations in the composite samples collected during the summer of 2022 had an average of 75.37 ug/L of total chlorophyll-a, exceeding the standard of 3.5 ug/L for Oligotrophic lakes. This concentration classifies the East Basin of Lac La Biche Lake as Hypereutrophic (excessive productivity, nutrients, and algae growth).

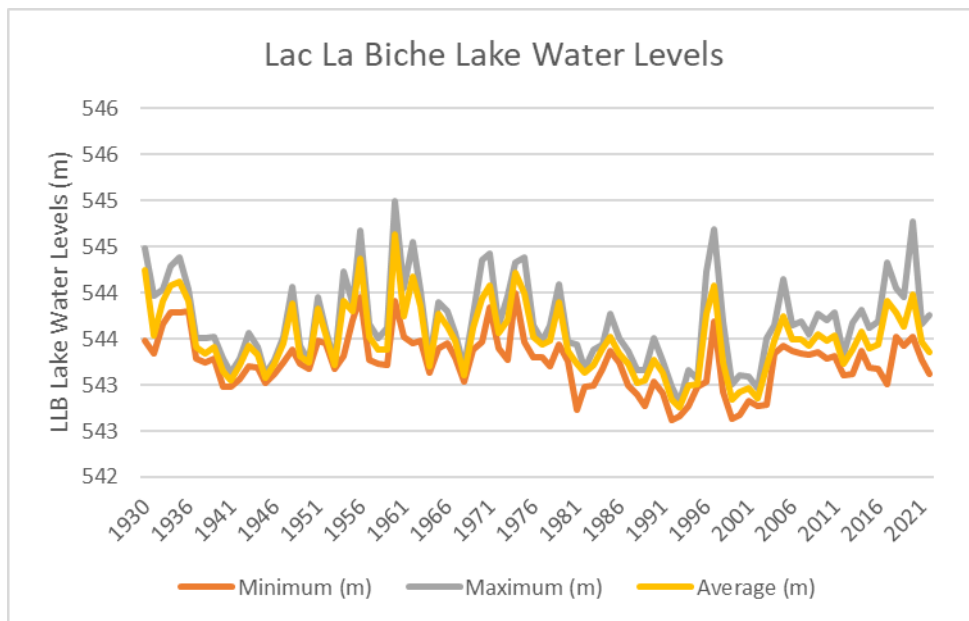
Figure 16: Historical water levels of Lac La Biche Lake

Lac La Biche Lake water levels have been monitored by Environment Canada every year since 1930. There are large fluctuations seen in the water levels recorded as seen in Figure 15 below.

During the spring of 2020, Lac La Biche experienced high levels of precipitation. The precipitation combined with other unknown variables, resulted in extremely high-water levels. Flooding occurred throughout the watershed in early June 2020. The high-water levels remained for the duration of the summer and resulted in a significant improvement in water quality. Nutrient levels were much lower (demonstrated in Figure 13 and Figure 14 showing historical results of nutrients) and Cyanobacteria (blue-green algae) blooms were delayed until August (opposed to June/July).
